Bringing Car 33 Back to Life

In Time for the 100th Anniversary of the National Park Service

For the second year in a row, East Troy Railroad Museum volunteers delivered a restored Chicago, South Shore & South Bend car to the operating roster.

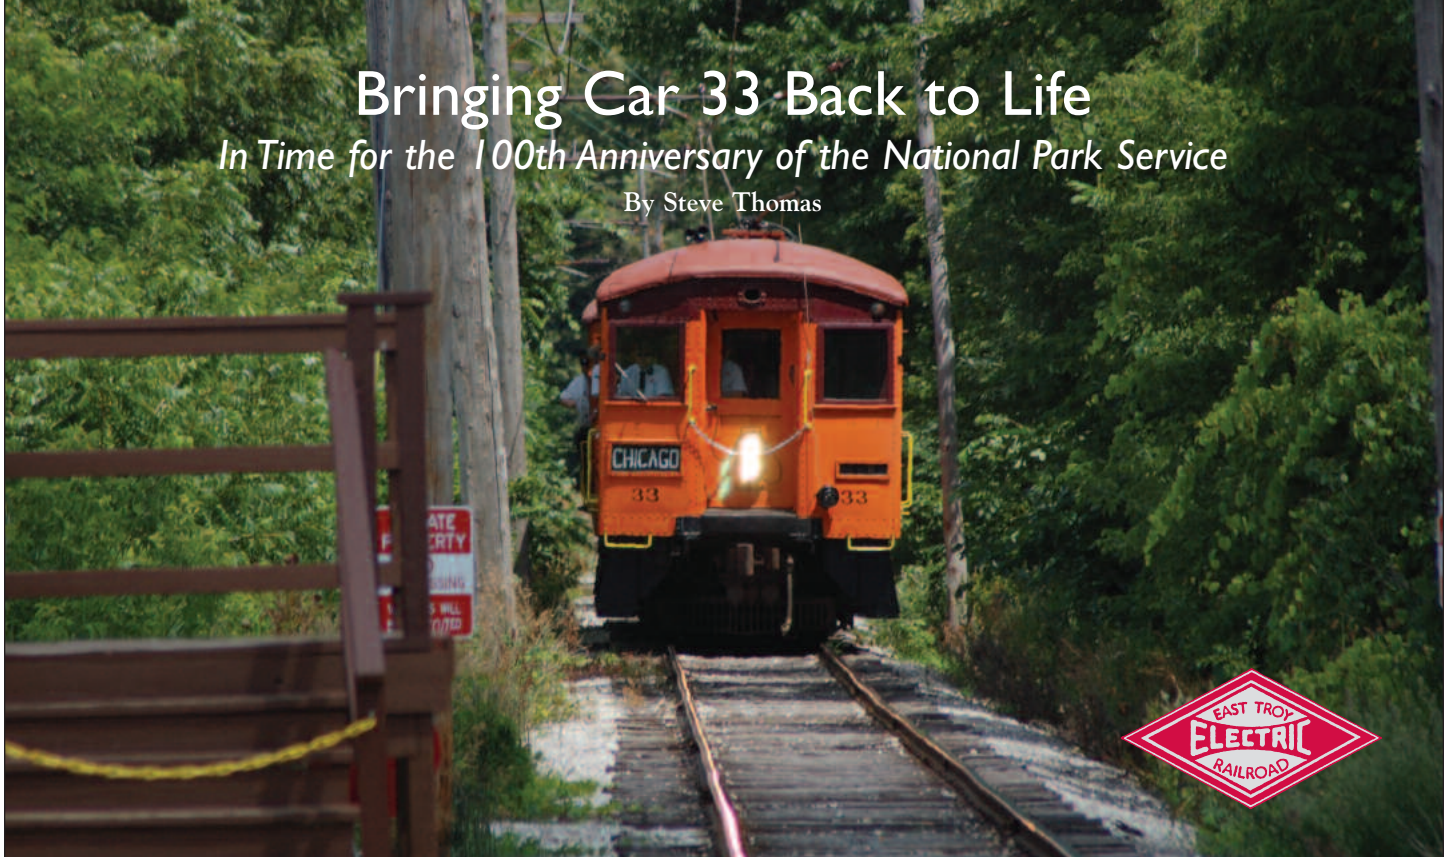
▲ Car 33 approaches the platform in East Troy on one of its regular runs on July 16, 2016. —Photo by Tom Fleming, photos by Ryan Barry unless otherwise noted. Photos are generally shown in chronological order.

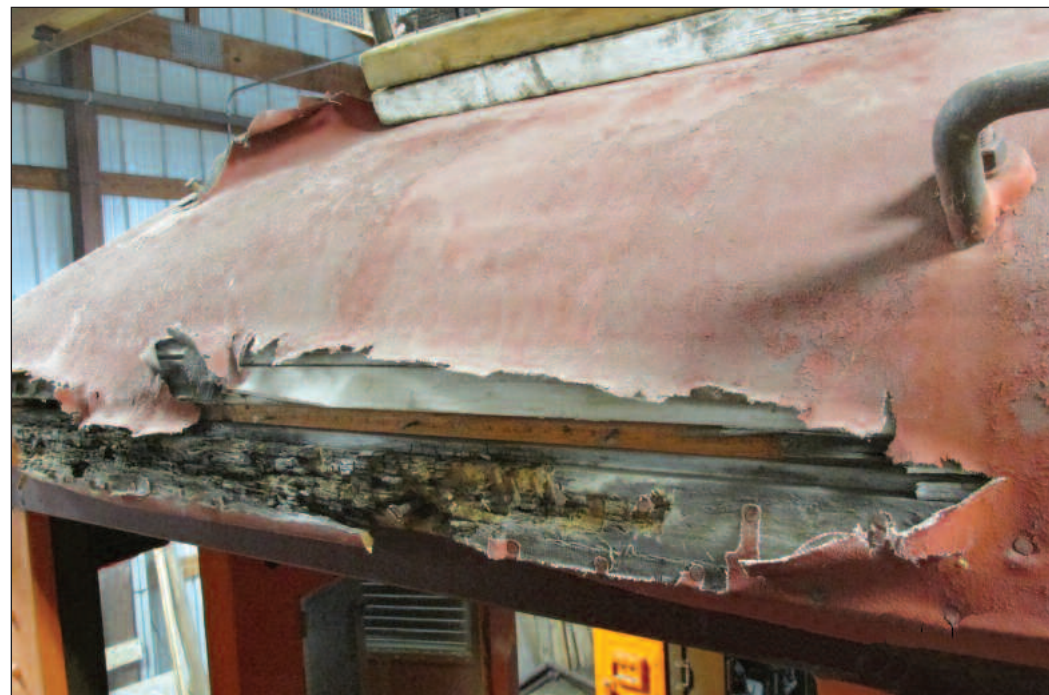
▼ The old canvas roof covering had become brittle and many holes were visible, including a large tear along the roof trim seen in this photo. The wood beneath had rotted away. The volunteers did not know how much damage would need to be repaired on the roof decking until the canvas had been removed.

“We also knew there were some places where the wood decking and trim was rotten, but we didn’t know how bad it would be until we got everything off the old roof and removed the canvas,” said Jaehn. “It turned out that the wood deck was in pretty good shape and the rotted spots were repaired fairly quickly.”

Fred Biederman, who did most of the deck repairs, had to replace about half of the trim — also called the “nail board” — fashioning new poplar boards to match the existing ones. The trim was fastened to the car’s steel structure using machine bolts. So a big part of the job was getting all the old machine bolts out and drilling and re-tapping the ones that could not be removed. Biederman also marked the steel structure below the roof deck so that a new catwalk could be installed once the roof was finished.

With the catenary, roof vents and catwalk removed — and every rotted section of deck and trim repaired — the crew sanded the deck. The sanding helps find the remaining tacks and staples left from the old roof, ensuring that the new canvas is not damaged when it is placed on the roof. Next, the team stapled butcher paper to the whole roof. The butcher paper ensured that the new canvas could move freely when it was placed and stretched.

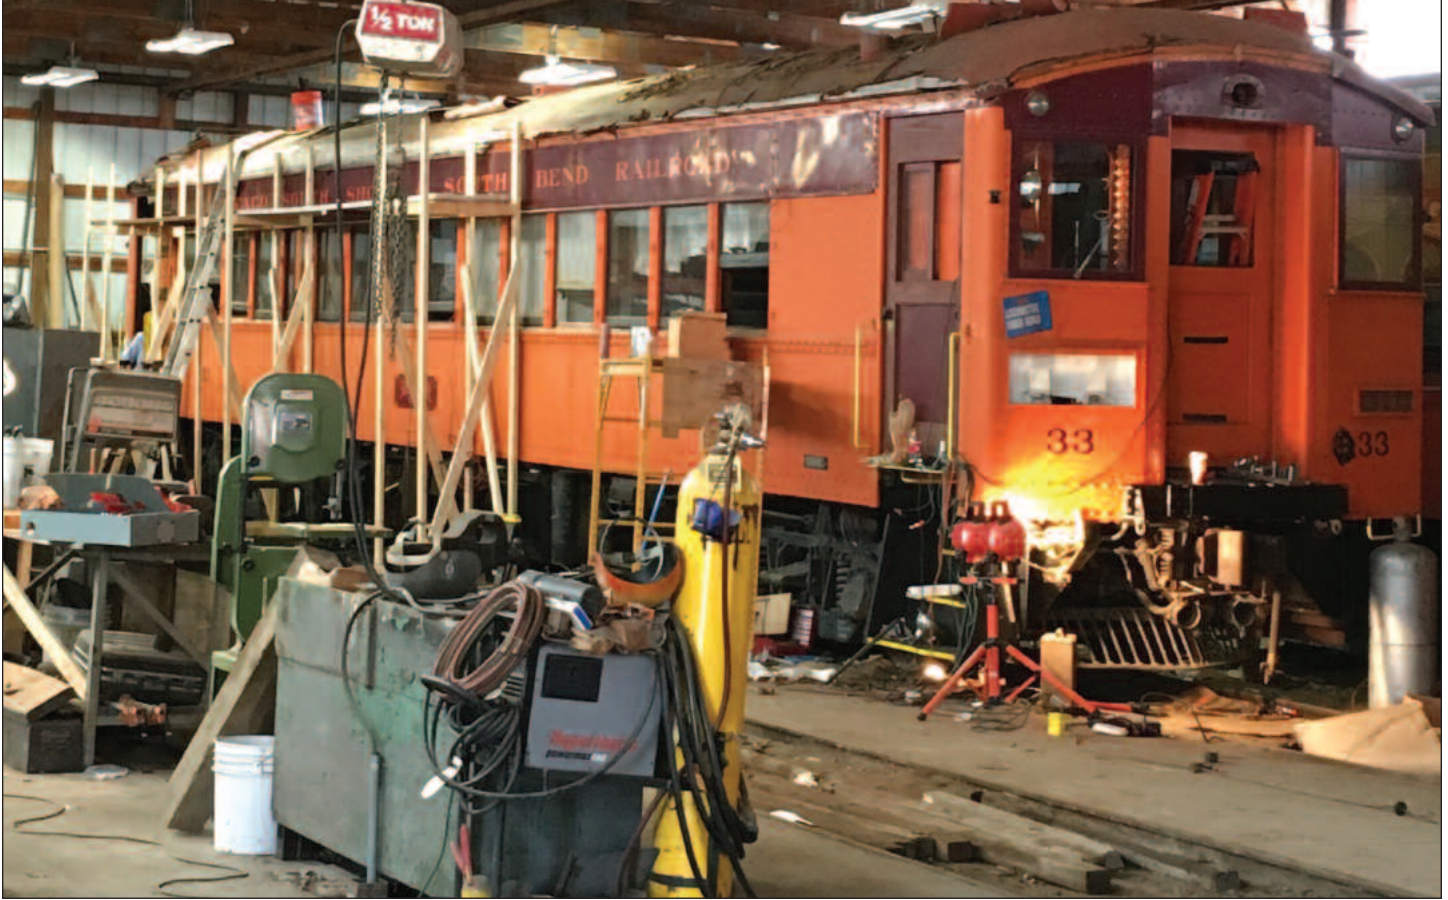
▲ Car 33 is shown in the East Troy car barn, where the restoration took place. The pantograph and most of the vents have been removed from the roof in this photo.

Jaehn said the pressure built toward the end of the project, because the roof needed to be replaced and there was quite a bit of graffiti on one side of the car. Replacing the roof was not an easy task, because the South Shore line uses pantographs to connect to the overhead trolley wire. The pantograph on car 33 had to be removed and replaced by two new trolley poles so that the car could operate on the East Troy Railroad. There were also 18 roof vents to remove, and each vent had 36 screws.

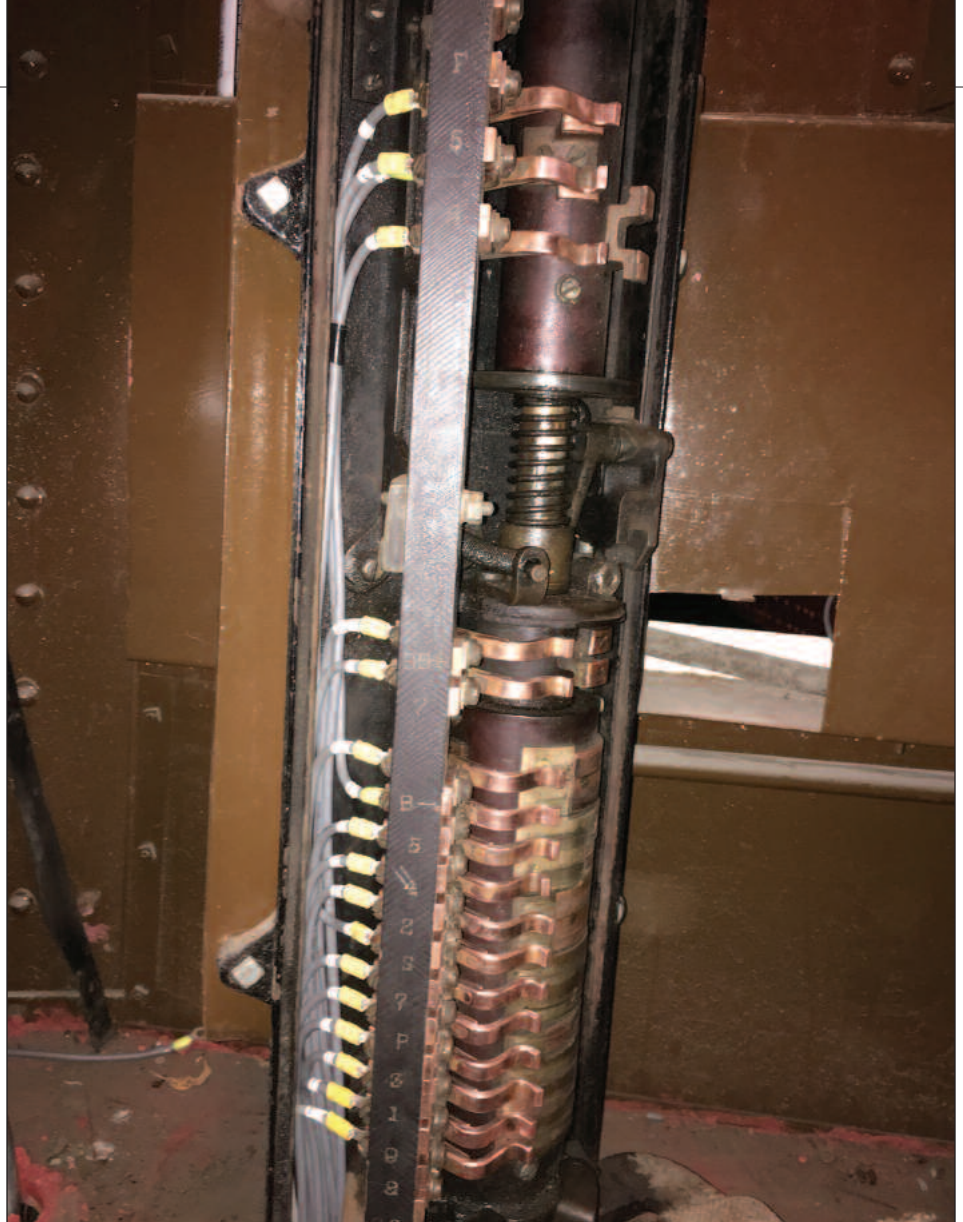
▲ Both control stands were removed, disassembled, cleaned, rewired and lubricated before being reinstalled in car 33. ▼ Volunteer Ben Killips works to repair and reassemble one of the “new” headlights for car 33, while Dustin Robinson and Ryan Barry look on.

It was late May before the wiring and electrical tasks were complete. Those tasks had included cleaning and rebuilding the control stands at both ends of the car, reinstalling the fuse banks, and cleaning and refinishing the cab switches and cabinet.

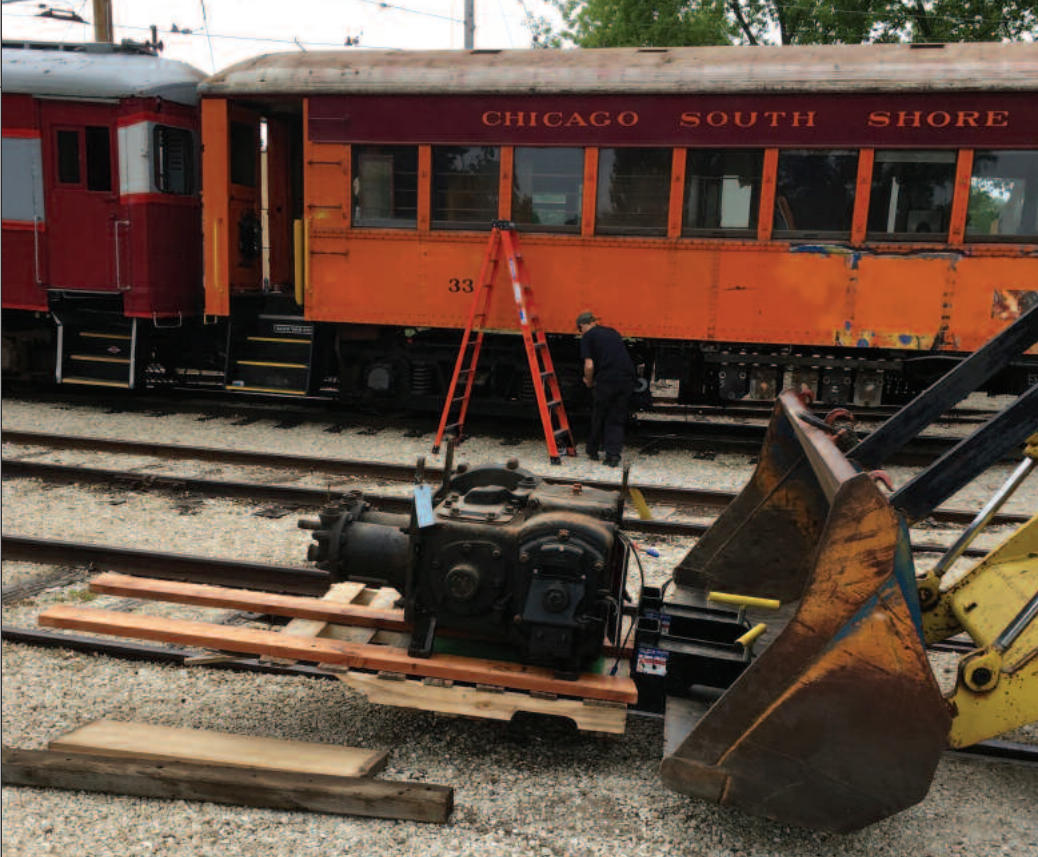
▲ Car 33's "new" air compressor has been repaired and tested and is ready for installation. This large compressor is so heavy that it could only be moved with the assistance of a forklift attached to the railroad's front end loader. ▼ Ryan Barry works beneath the car to splice and tape some of the wiring that had been cut when the car was being cosmetically restored in Indiana.

repair, and we needed to find a new 600-volt compressor.”

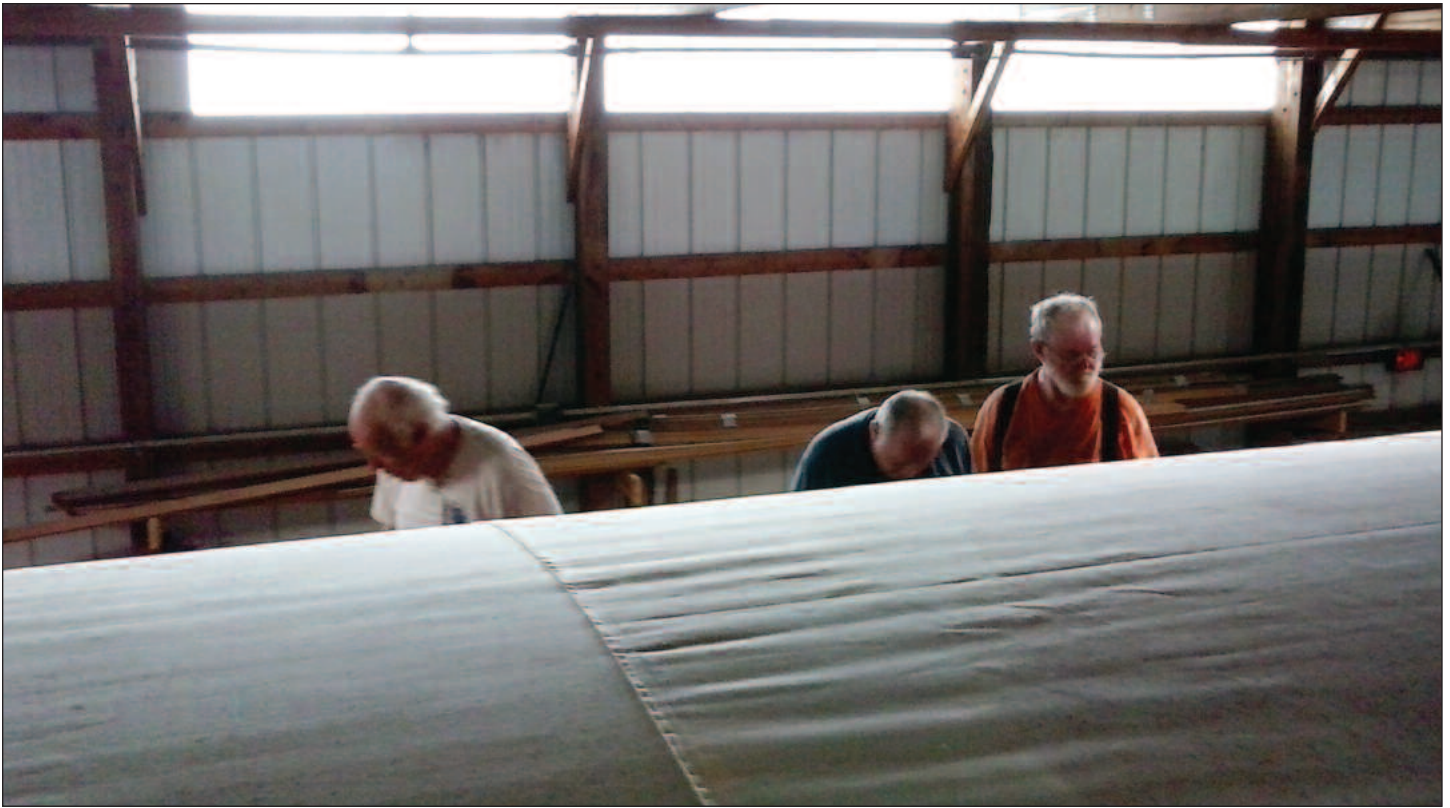
▲ Three of the roofing team volunteers stretch the canvas on top of car 33. From left are Fred Biederman, Skip Lichter and Dennis Woodward. ▶ Mike Jaehn uses a sander to remove a large area of graffiti from the car just two days before the dedication ceremony. Some of the “artwork” is still visible in the lower right-hand part of the photo.

to the sun and the elements. Wooden clamps were fastened to the canvas at both ends of the car and attached to turnbuckles to help stretch the canvas.

After allowing the canvas to stretch for about a week, and carefully adjusting the turnbuckles every couple of days, the team flipped over the canvas and began stapling it to the nail boards. Working from the center of the car, they stretched the canvas and attached it on both sides at the same time, gradually working toward the ends of the car. Once the canvas had been attached, they applied five coats of stain, waiting for the coats to dry in between applications.
