# Interior Restored, CSS&SB Car No. 9 Rejoins the East Troy Railroad

East Troy Railroad Museum volunteers were proud when restored Chicago South Shore & South Bend car 9 rejoined the operating roster on July 4, 2015.

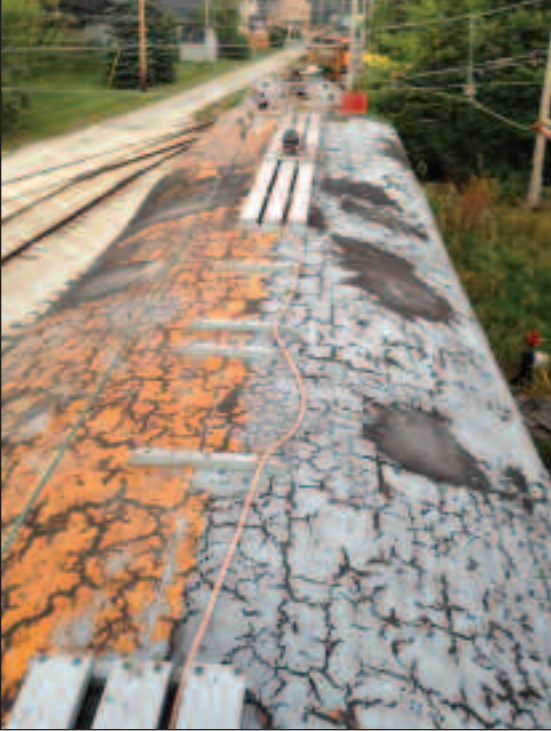
◀ The cracked and multi-colored roof of car 9 in September 2013.

“At some point the roof had been painted with grey latex paint and the paint had deteriorated over time,” said Barry. “Someone had also applied linseed oil, but perhaps not in the right order. It appeared that the latex paint was put on top of the linseed oil. So the roof was very sticky.”

Barry stripped off the grey latex paint, repaired some minor holes in the canvas, and re-stained the roof in grey. But the coloring turned out very uneven. The sticky linseed base was part of the reason, but it also appeared that part of the roof had been refinished a different way than the rest. It just didn’t match, and it didn’t look good. At that point Barry, with the help of another East Troy volunteer, Fred Biederman, decided to use a darker stain. The red oxide color they chose matched the color of the roof of South Shore car 33, also at the railroad. It covered up the discoloration of the grey, and it seemed to match several historic photographs found of South Shore cars with darker roofs.

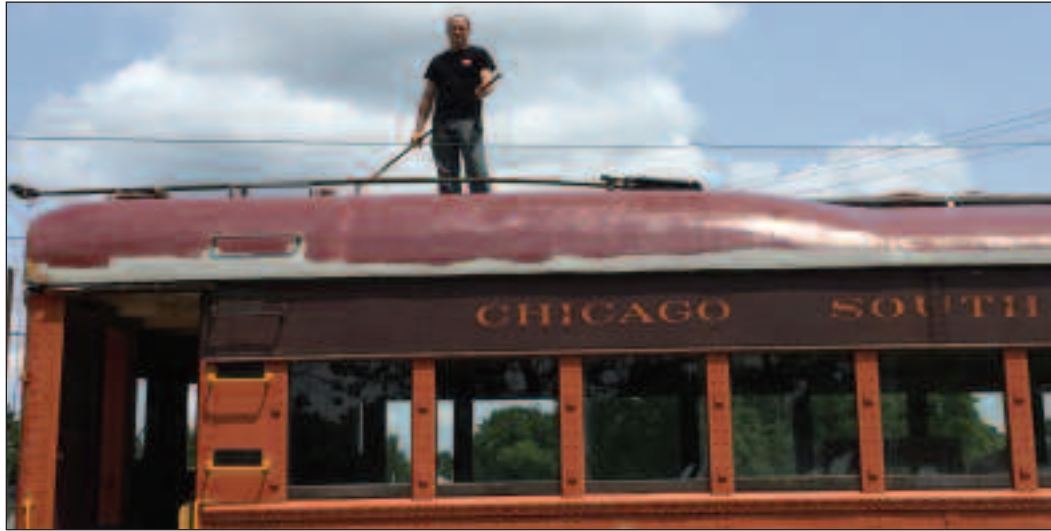
▼ Ryan Barry is shown on top of CSS&SB car 9 re-staining the roof. —Ryan Jonas photo

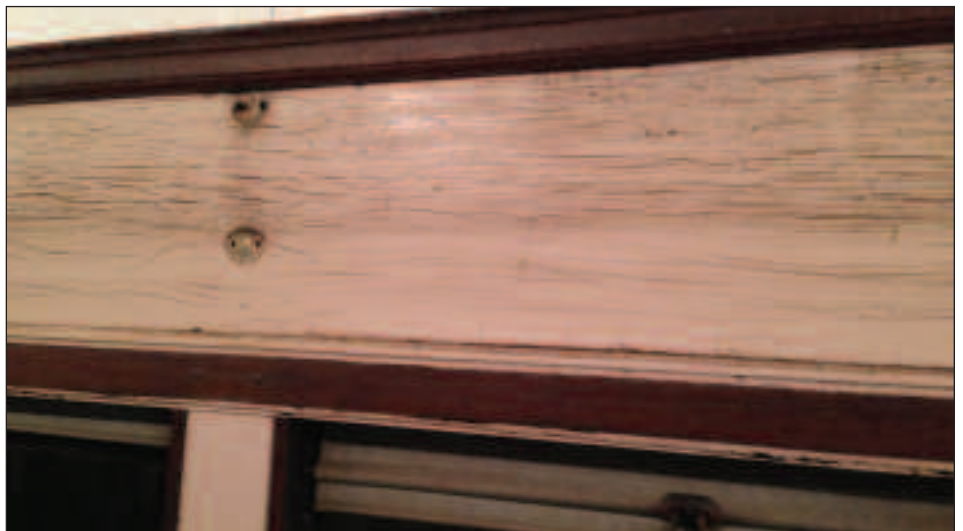
▲ After removing the luggage racks, the color of the original wood could still be clearly seen. The shellac had deteriorated and cracked, but Barry could see the original color. His goal became matching the original color and finish.

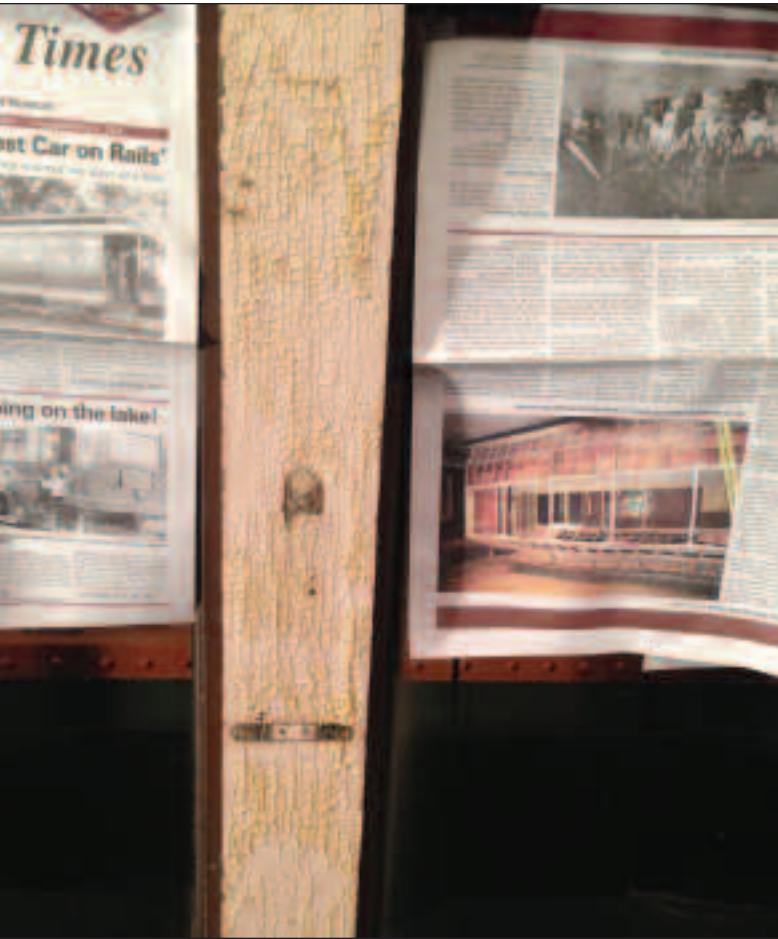
▲ In theory, after applying the chemical paint strippers, it should have been possible to go through with a putty knife and peel off all the layers of paint. But in this case, only two or three layers at a time could be removed. Since there were five or six layers of paint, the chemicals had to be applied and stripped two or three times for each section of painted wood.

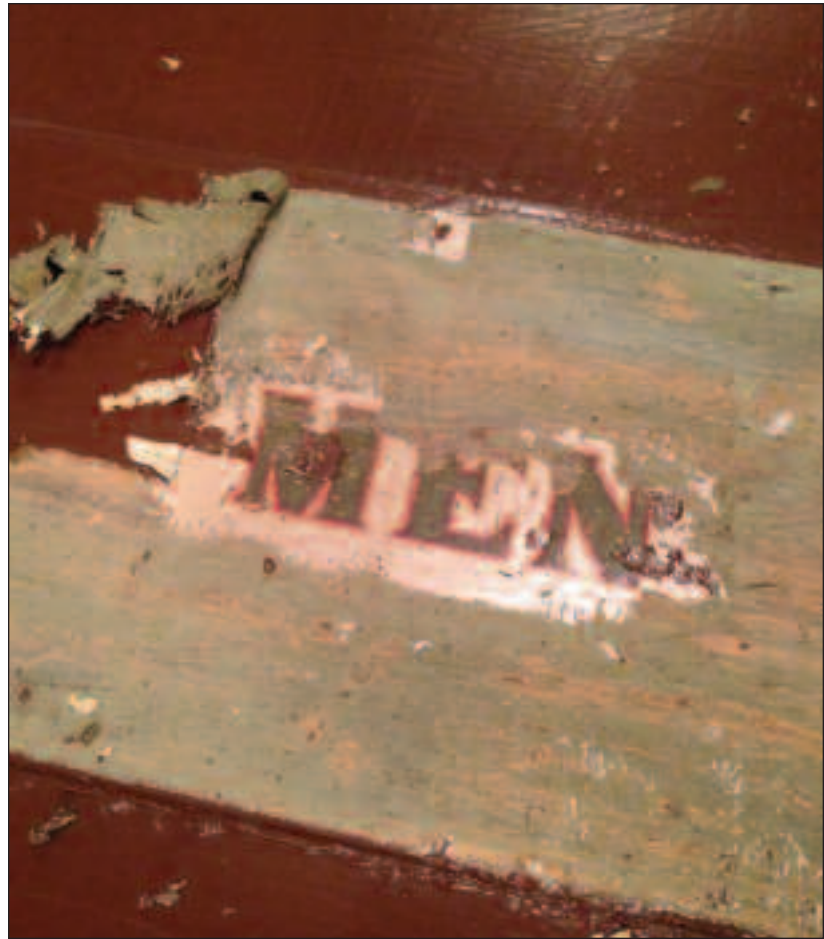
▼ When Biederman started stripping the bathroom doors, he discovered that they were lettered "Men" and "Women." The layers of paint on top of the lettering are clearly visible in the photo. The top layer was a thick brown color; tan was next, then olive green. It appeared that tan had been used as a primer or as a base below the green. Then there was a white layer; and finally the wood finish with shellac, which had deteriorated before the first layer of paint was applied.

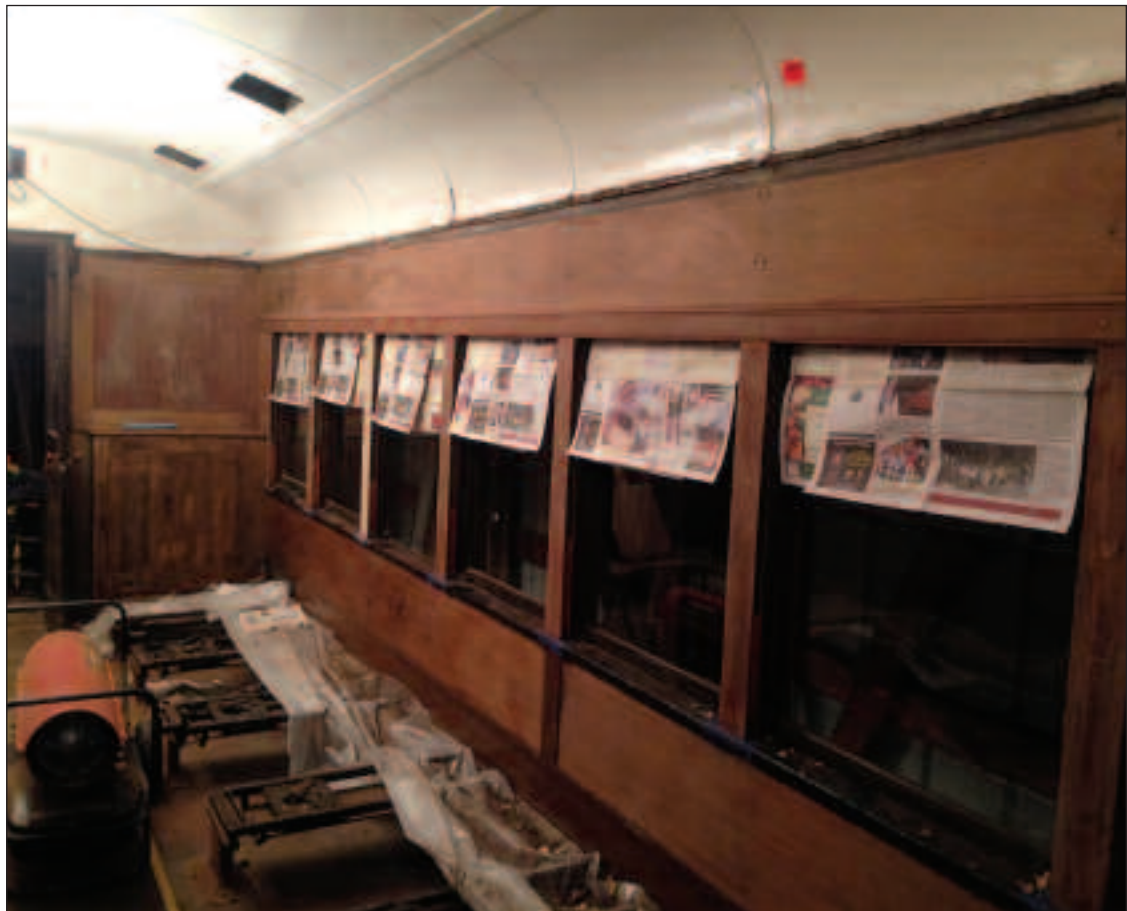
► A view of the car after the initial stripping. Note the cylindrical heater on the lower left. Much of the initial work was done over the winter of 2014 when temperatures were often in the 20s.

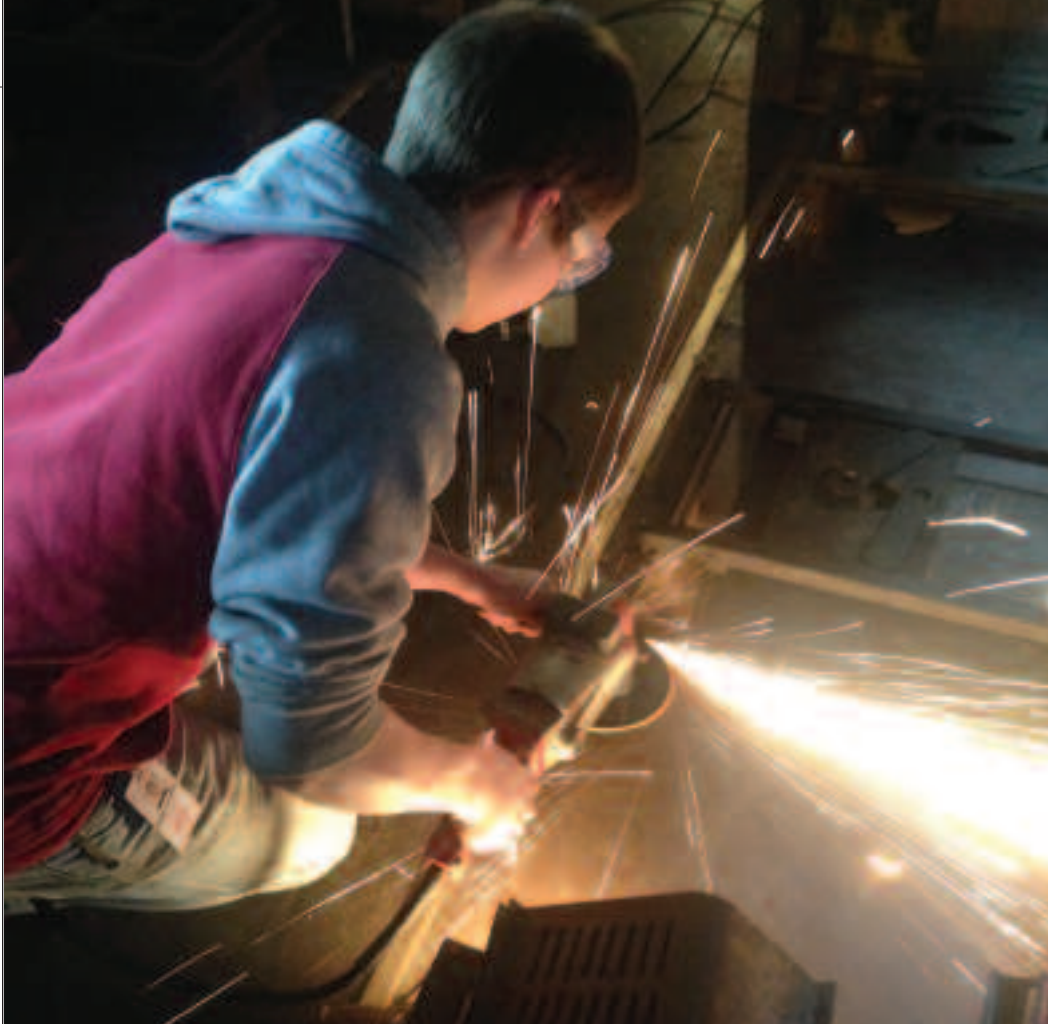
◀ Volunteer Adam Loeffler used a grinder to remove the heads of the bolts holding the seat bases in place. The nuts holding the seat bases beneath the car were completely rusted and very difficult to access. The easiest way to remove the bases was to grind off the heads of the bolts and pound the bolts through the bottom of the car. After they were removed, all the seat bases were sandblasted and repainted.

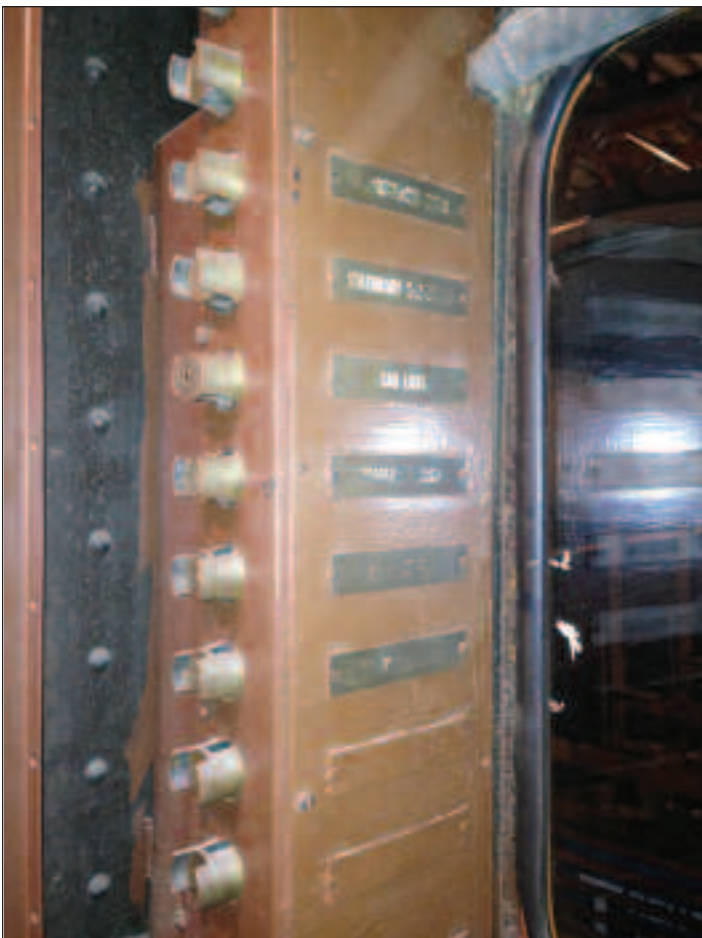
Ryan Jonas, president of the railroad, redid all the cab switches. ▶ He had to remove the outside plate around the control box in order to remove and refinish all the plungers and contact fingers for the switches. ▼ The cabinet was also repainted and reinstalled with new brass labels for the switches.

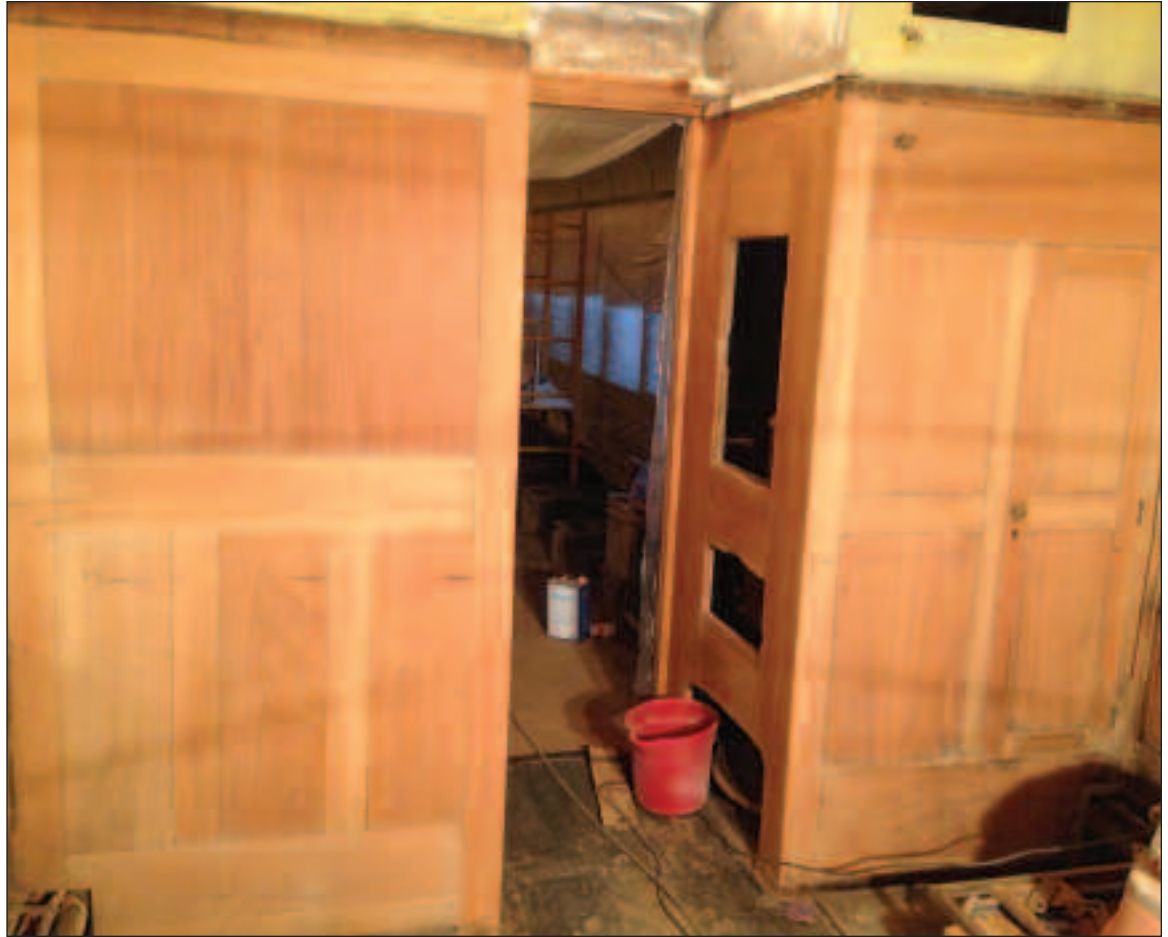
▶ This photo shows the sanded walls of the bathroom and the boiler room. The car came from the factory with thermostats and automatic temperature controls. The boiler, which is still in place, was coal-fired, and used on colder days when the electric heat could not keep up. Water circulated through the boiler to be heated and then circulated around the car. It was a basic hydronic heating system. The refurbished car has a new 600-volt electric heating system, but uses the thermostat that was on the car when the East Troy Railroad received it.

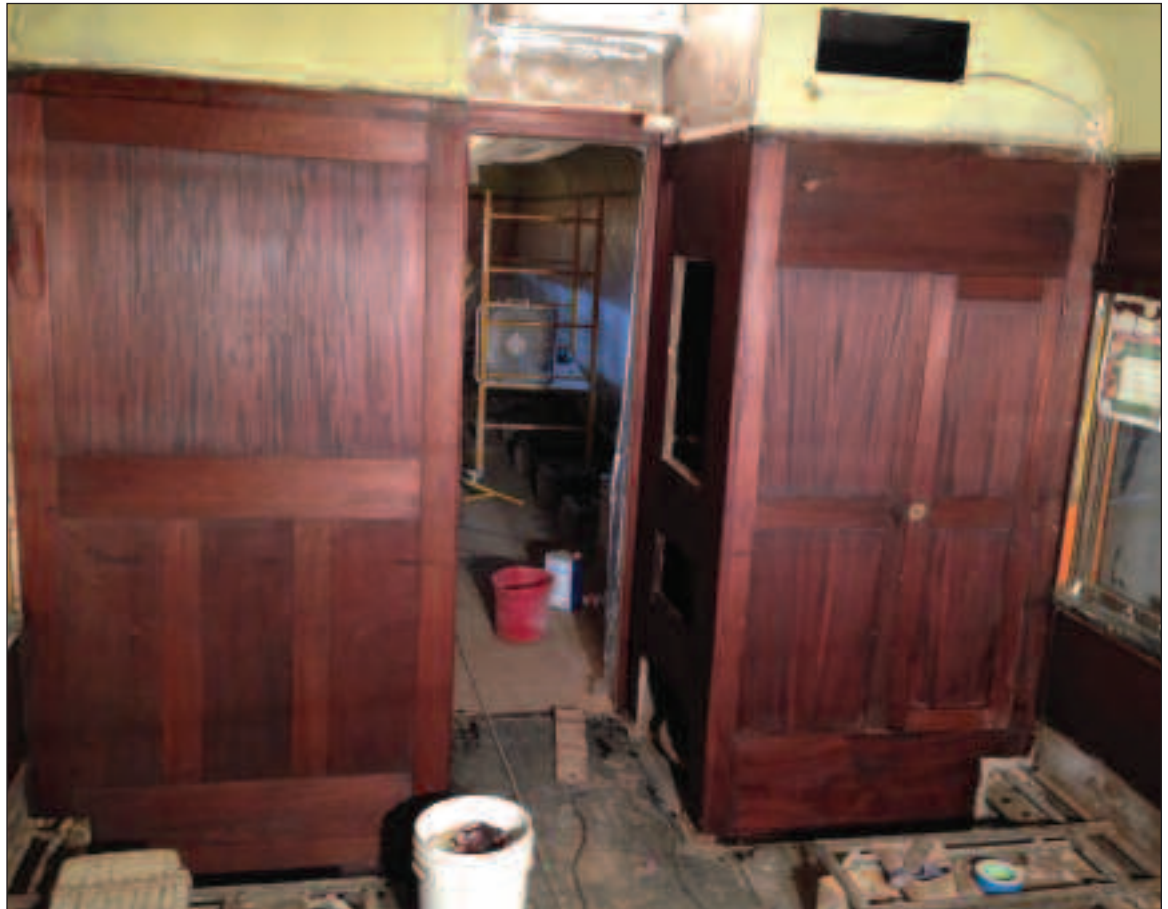
▶ The walls have been stained in this photo. Trim pieces were stripped and stained separately. The final finish started with several thin layers of shellac. At this point Barry did some additional research and learned that shellac is not the best choice when the wood will be exposed to significant variations in temperature. So he added one or two thin layers of polyurethane on top of the shellac.

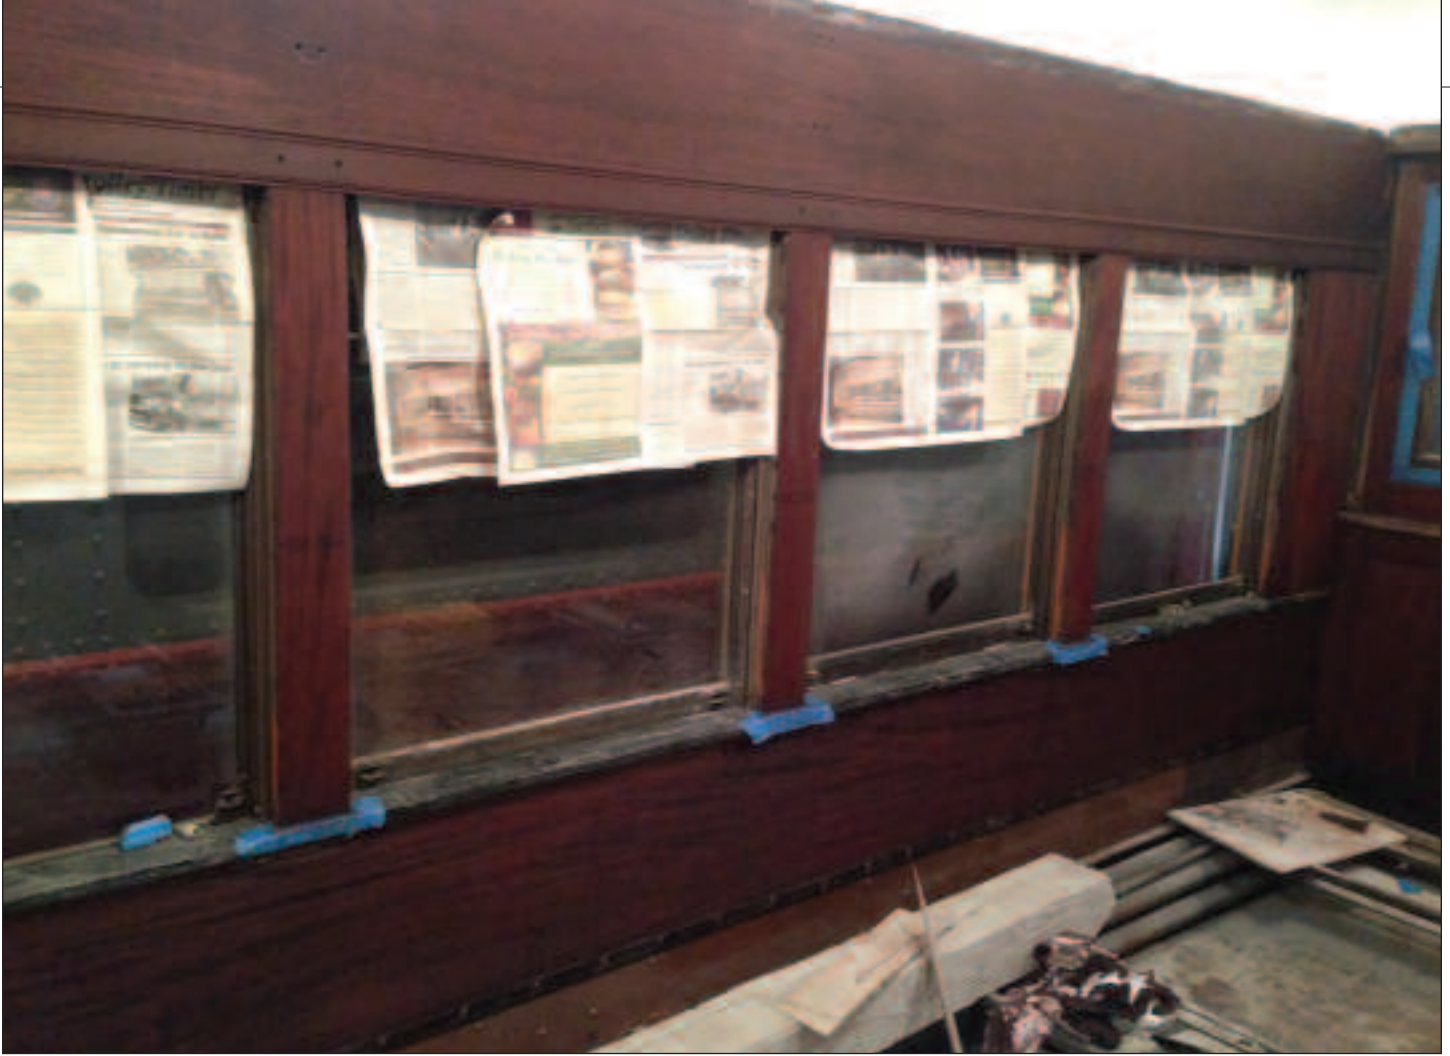
▲ The rest of the car has received a layer of stain in this photo. Barry and Biederman repaired and repainted the trim pieces below each window. The metal tracks on both sides of the windows were also removed, repaired and refinished. This made it easy to replace some of the windows that had been cracked or damaged over the years. The result is windows that once again operate properly and safely.

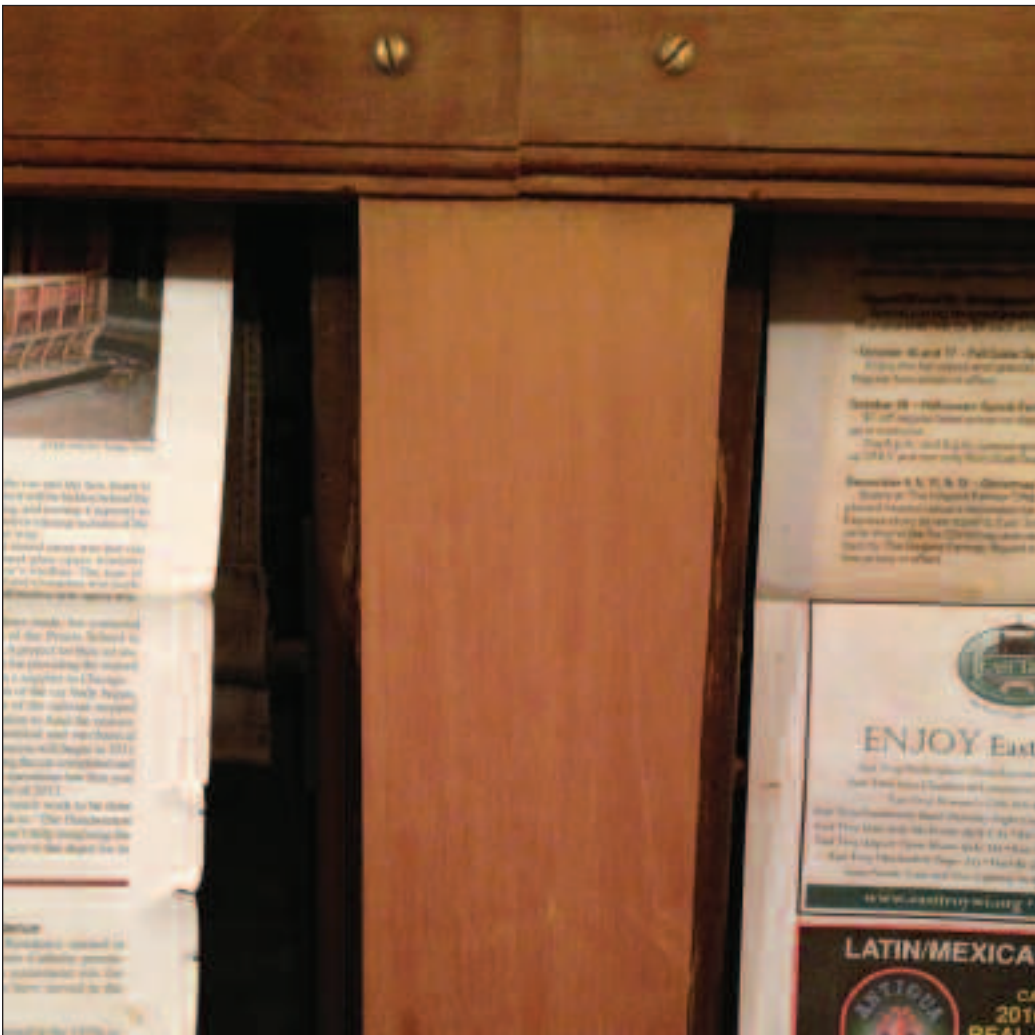
◀ The wood uprights between windows were sanded to prepare for refinishing. The sanding was done in multiple stages, starting with 120- to 150-grit paper, moving to 180-grit, and finishing with 220-grit for a really smooth surface. Two of the uprights had to be replaced because they had deteriorated too badly to be saved.

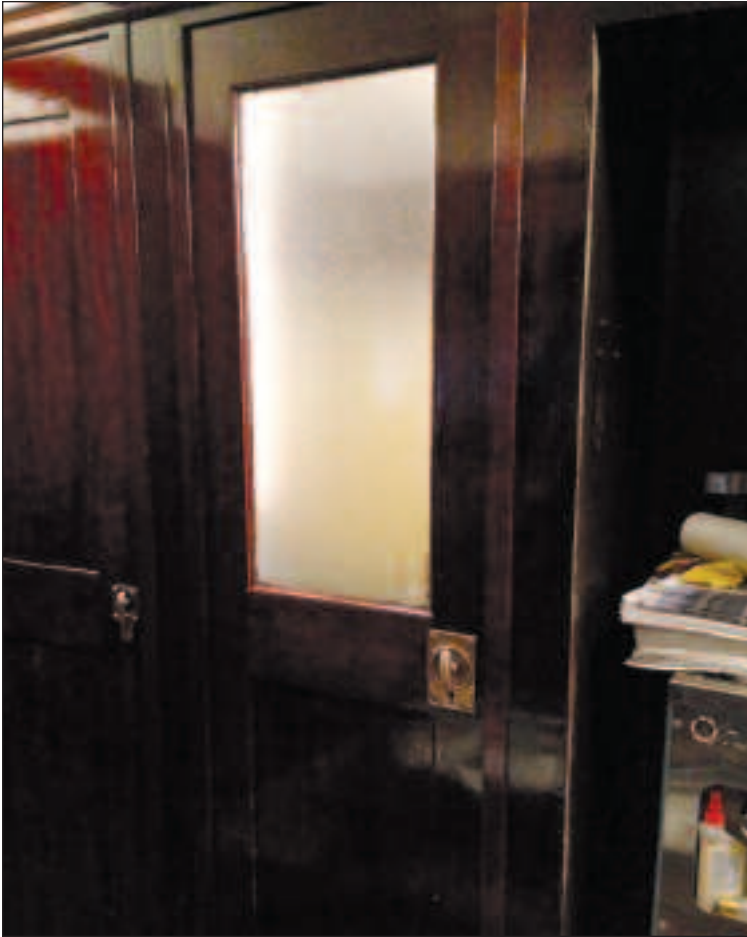
▲ This photo shows the refinished bathroom door. The area with frosted glass had been filled in with plywood at some point, and it would not have looked right if they had tried to stain the plywood to look like the mahogany in the rest of the car. So they replaced the plywood with frosted glass. The door trim was replaced because it had been water-damaged. The door hardware is original. It was removed and refinished before being reinstalled.

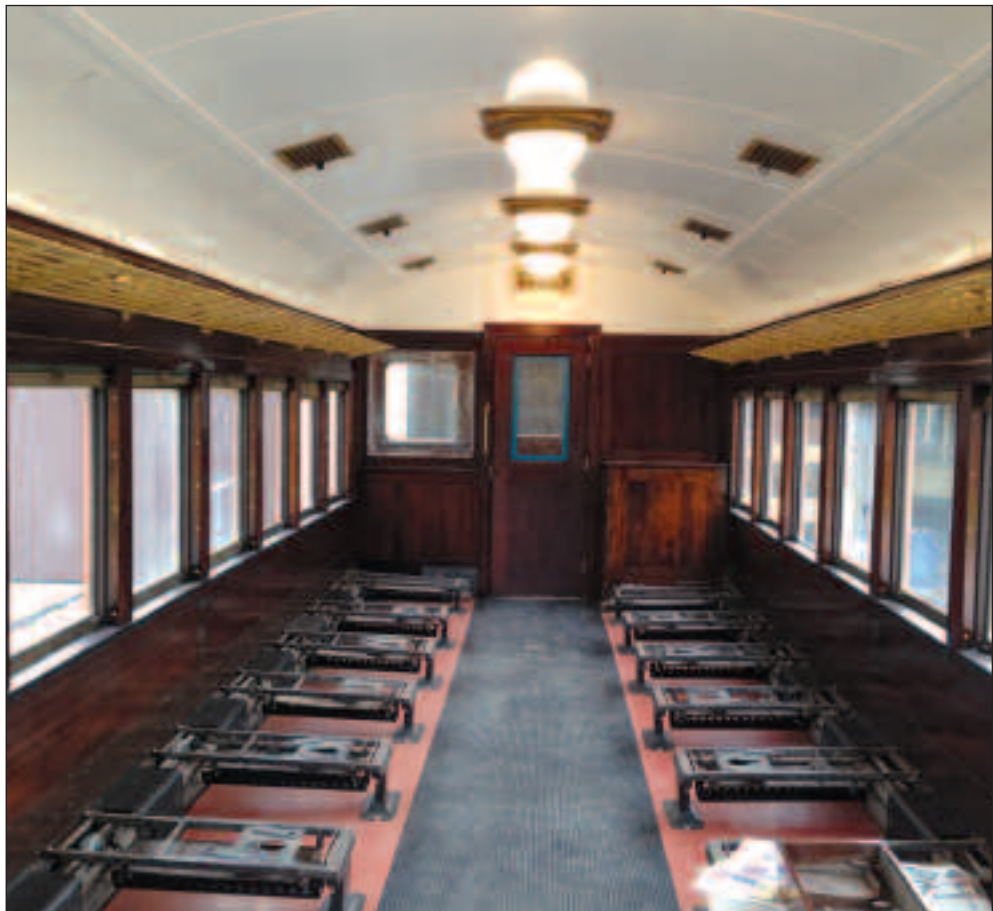
► In this photo, the floor is done, the vents are back, the seat bases are in place, and the luggage racks have been reinstalled. The luggage racks were sandblasted and repainted in gold.

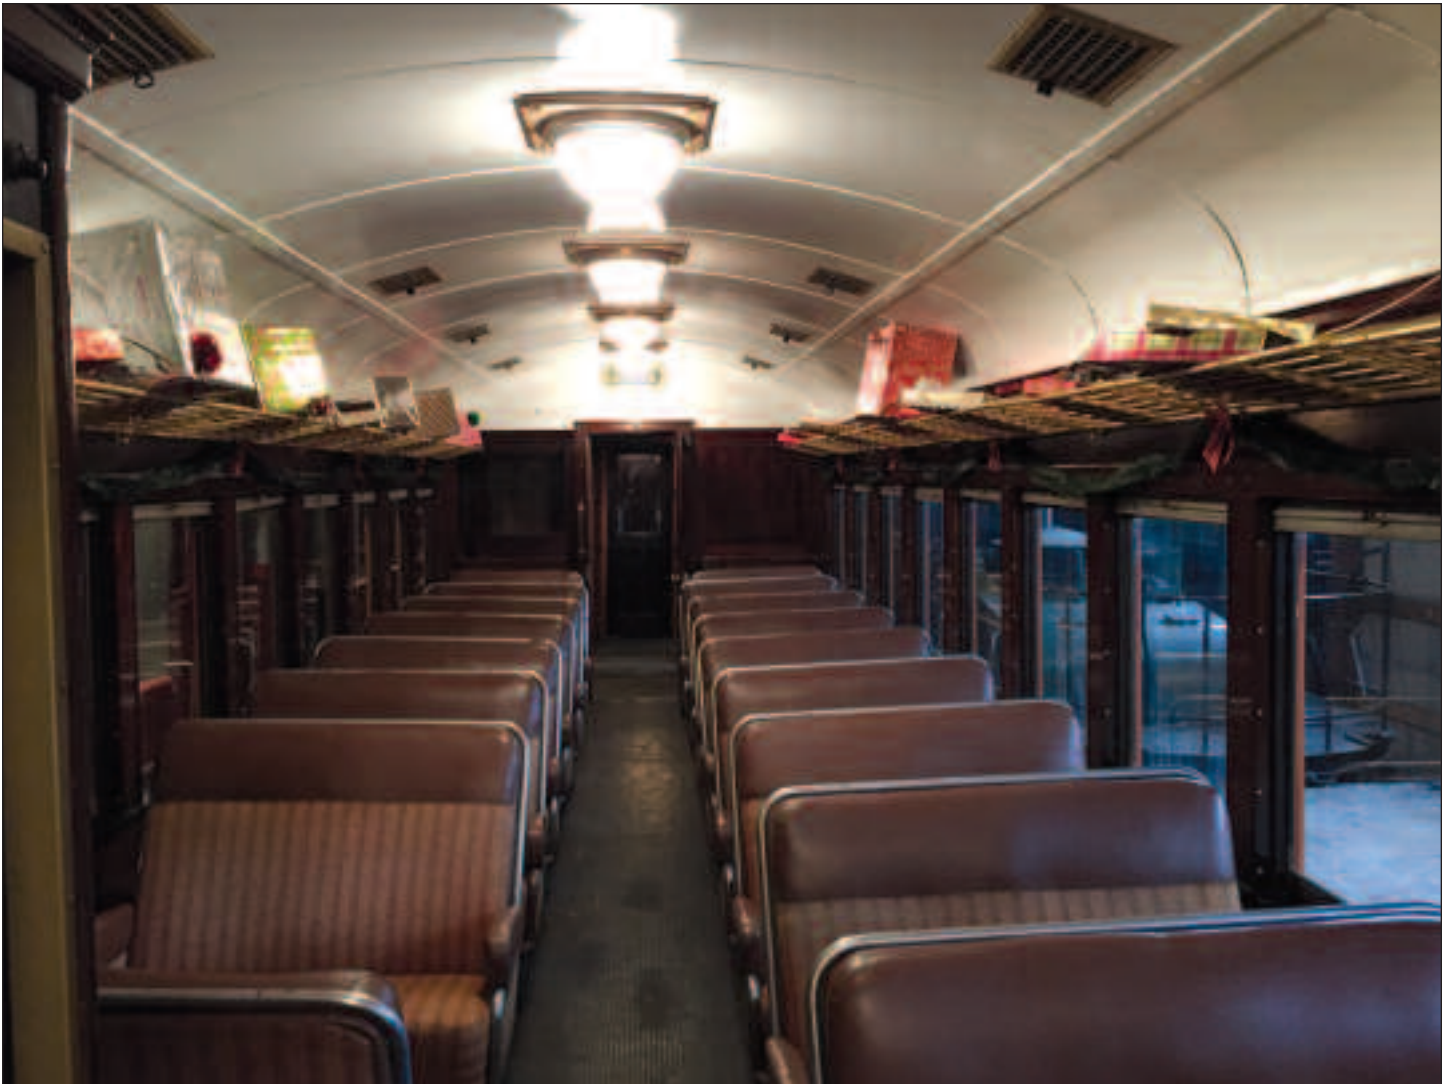
▲ This is the finished interior, decorated for the Christmas Train. The seats came from CSS&SB car 107. The seats that had been in car 9 were pretty worn; some were ripped and had been repaired with brown duct tape. The fabric on the seats from car 107 was in very good condition and there were no visible tears or repairs. The seats were steam-cleaned after installation. —Ryan Jonas photo

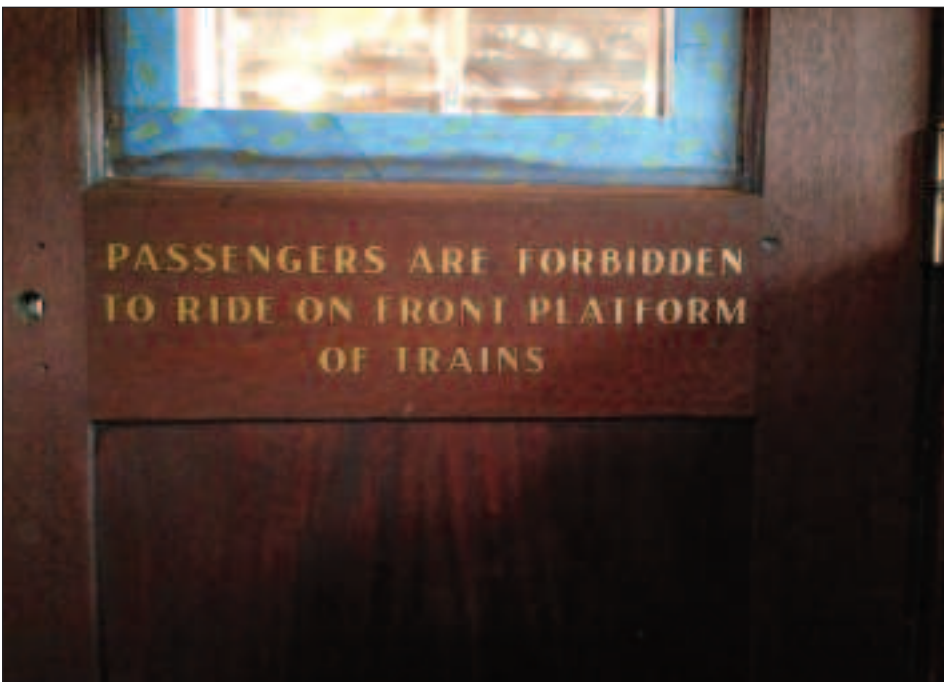
▲ Decals were created to match the original lettering at the end doors of the car. They were applied and then coated with a thin layer of polyurethane.

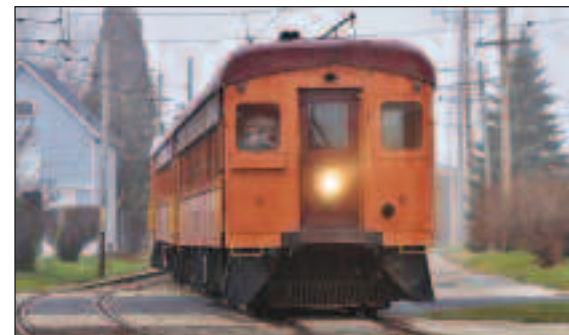
▼ Chicago South Shore & South Bend car 9 leads the East Troy Railroad Museum's Christmas Train out of the trolley barn on December 6, 2015. —Nikki Burgess photo
