The Nine Lives of Line Car D-23

By Steve Thomas

Over the past two winters, volunteers at the East Troy Railroad Museum repaired and repainted one of the original pieces of equipment from The Milwaukee Electric Railway & Light Co. (TMER&L). Car D-23 is a line car, which is a special piece of utility equipment used to maintain the overhead wire and the support systems that hold the overhead wire in place.

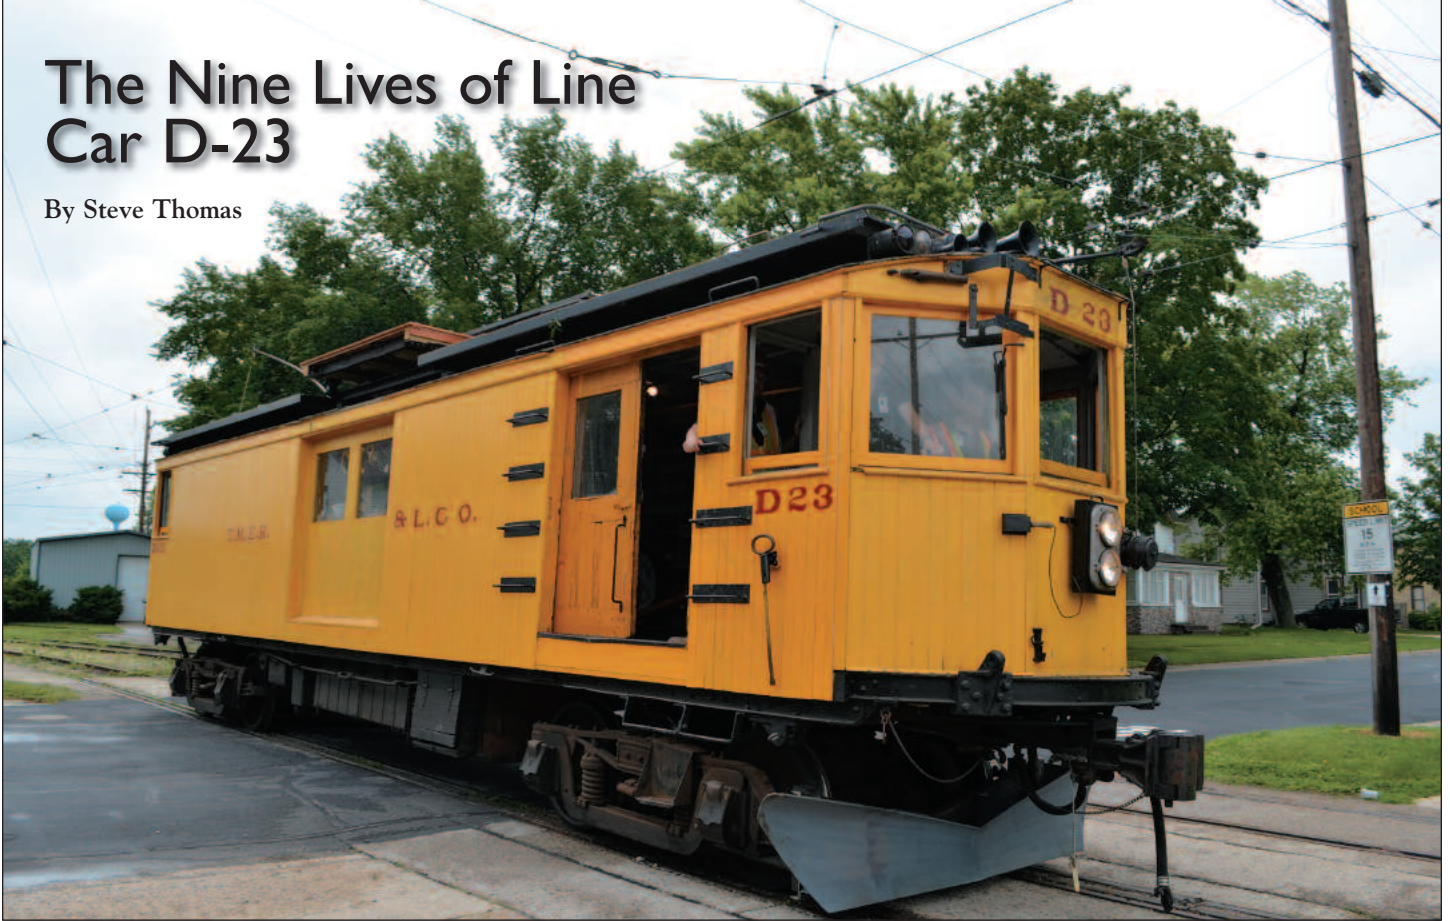
▲ Car D-23 crosses Division Street in East Troy in the summer of 2013. —East Troy Railroad Museum Photo Archives

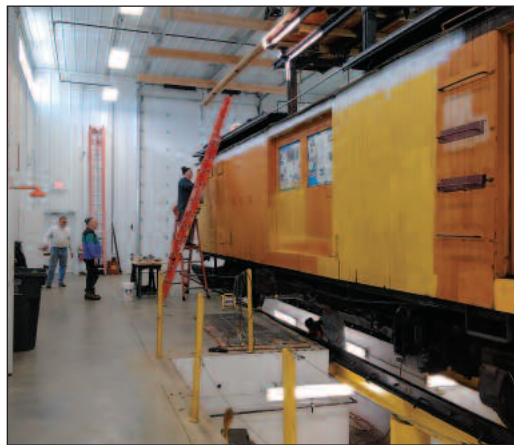
▲ Jerry Borzych, on the ladder, works to prime wood siding that has been repaired or replaced. Steve Southworth and Joe Buerger look on. —East Troy Railroad Museum Photo Archives ▲ Joe Buerger (left) and Mike Jaehn attach new trim to the car. —Ryan Jonas photo

Our volunteers noticed that the condition of some parts of the wood siding on the car had deteriorated. It was clear that a new coat of paint was in order. A volunteer team replaced the damaged or rotted wood, then primed the new sections and gave the entire car a fresh coat of yellow paint.

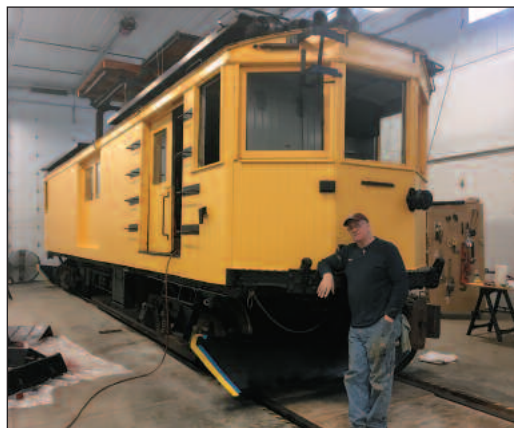
▼ Jerry Borzych poses after he had completed his work. —Tom Fleming photo ▼ John Jonas (right) passes new wicking material to Dustin Robinson and Elijah Jackson. Mike Heck is holding the railing in the rear. —Korey Kumbier photo

The crew also discovered that two bearings were cracked and needed replacement. Since the car is more than 100 years old, it doesn't have roller bearings, which were an innovation that didn't catch on until the 1940s and 1950s. It has old-style friction bearings, with journal boxes, which are designed to provide constant lubrication. They use a special type of oil and something called "wicking," which keeps the oil in contact with the axles and bearings. After the team installed the new bearings, they re-wicked and re-lubricated all the journal boxes.

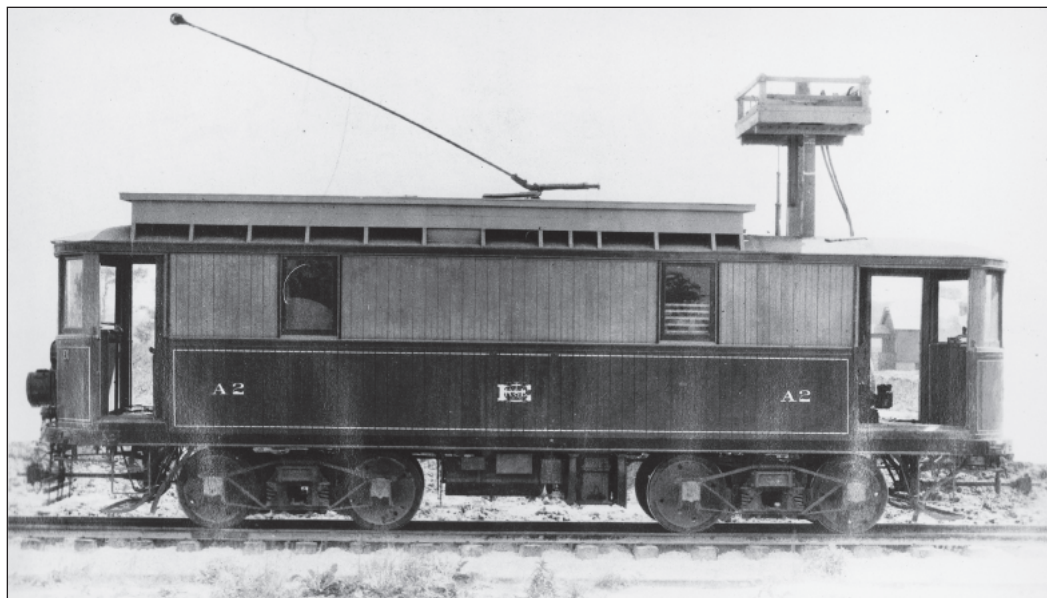
▼ The "builder photograph" of new line car A-2, one of two new cars built in the Cold Spring Shops in 1918 to replace single-truck models being retired. —Wisconsin Historical Society - WHS-142682

The single-truck line cars were gradually replaced with newer double truck line cars, such as car A-2 shown nearby. This car was one of two built by TMER&L's Cold Spring Shops in 1918. However, cars D-21, D-22 and D-23 remained important to the railroad. They were fast cars built to respond quickly on the interurban routes, while the other line cars worked mostly in and around Milwaukee. Car D-23 was substantially rebuilt in 1929, according to company records.

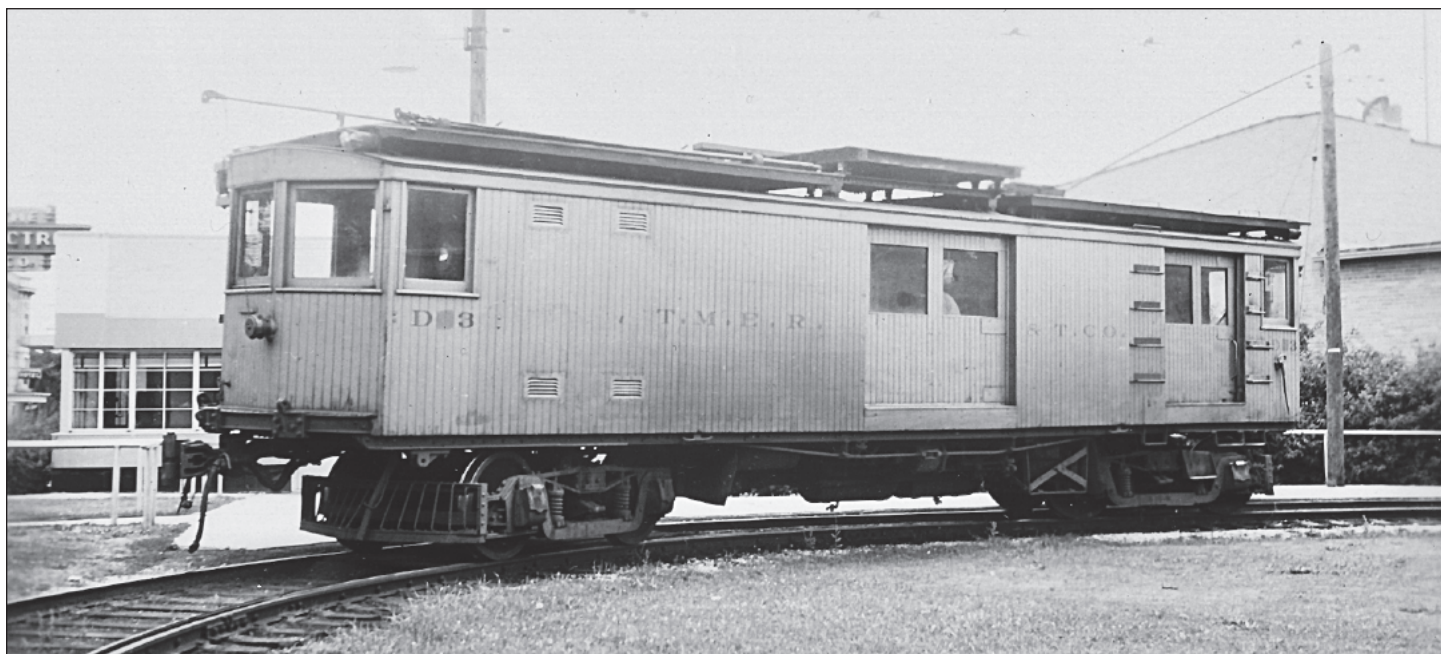
▲ Car D-(2)3 at the Port Washington turnaround sometime in the early 1940s.—Image courtesy of the California State Railroad Museum

When car D-23 started work at the Port Washington plant, it was renumbered as D-3 by simply painting out the “2” in its former number. Like car D-22 at the Lakeside Power Plant in Milwaukee, D-3 kept the rail lines into the plant cleared of snow so that the coal cars could be delivered on schedule to the coal-fired power plant. Wisconsin Electric was using steeple cab electric locomotives to move the coal cars, so the overhead had to be maintained as well. The photographic record indicates that D-3 continued working in this capacity into the late 1960s.

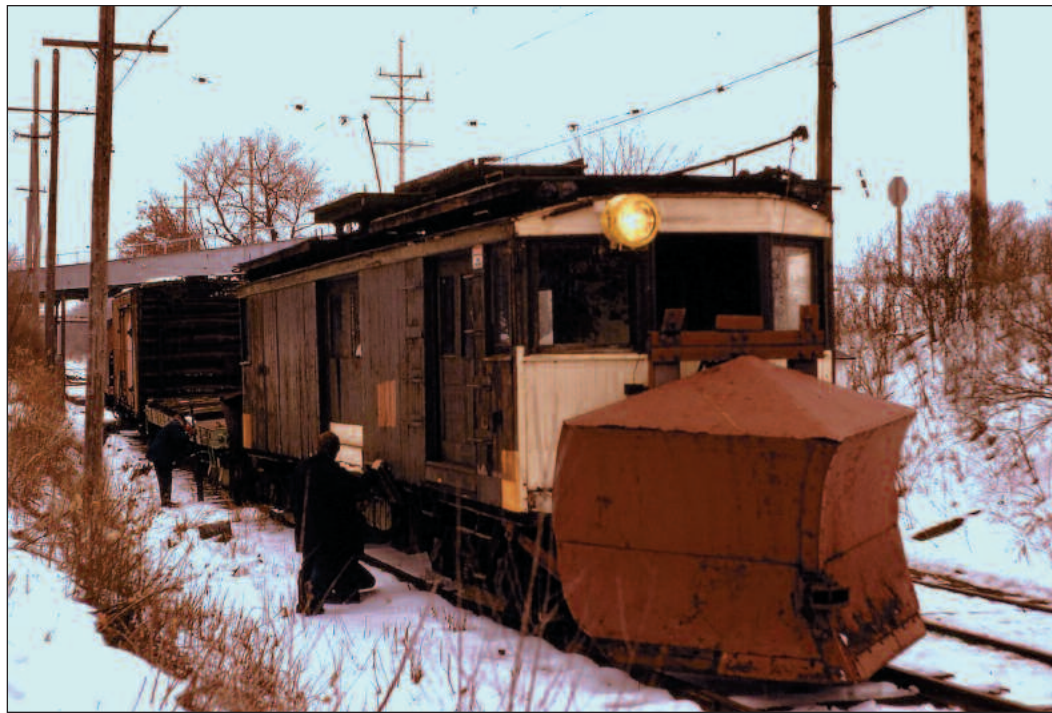
▲ Car D-23 at the Beulah siding, on the East Troy line, in January 1972.

The photo nearby, of D-23 at Beulah Siding in January of 1972, suggests that the car had not received much love from Wisconsin Electric in its later years there. However a photo from the late 1970s shows that the car had been re-sided and repainted, and the original D-23 number restored. Another nearby photo, taken in January 1982 shows D-23 and its crew making a repair on what looks to be a very cold day.

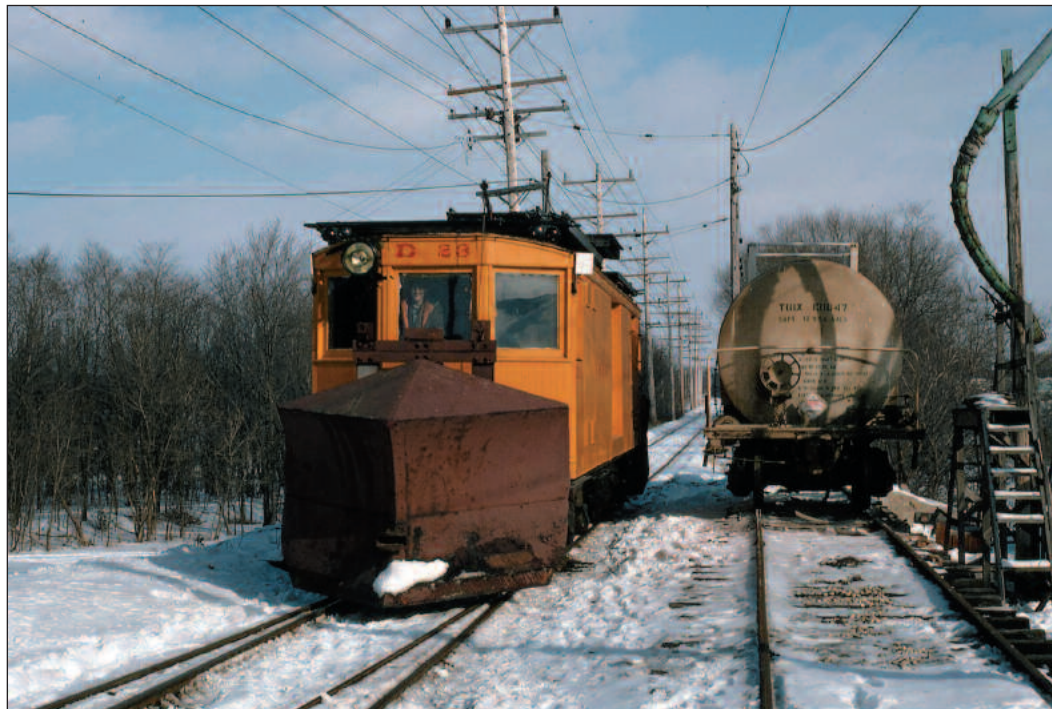
▼ Car D-23 just east of the East Troy depot (also the WEPCo substation) in the late 1970s. The car had obviously received some love and attention from its new owner. —Two Russ Porter photos

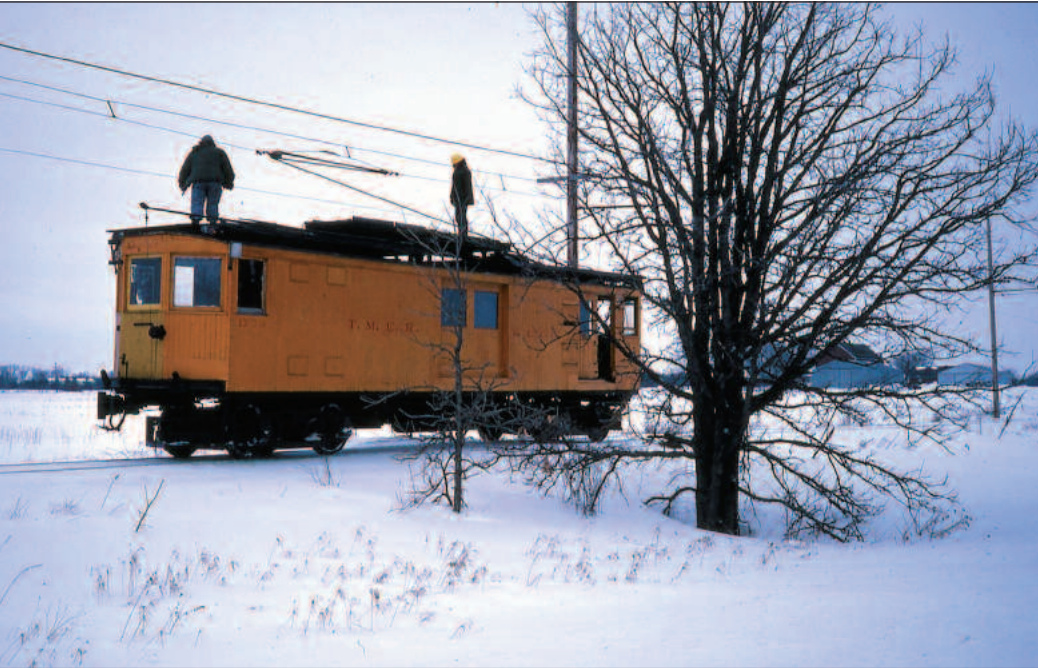
▲ The crew of D-23 makes a repair to the overhead line on January 30, 1982. —Russ Porter photo

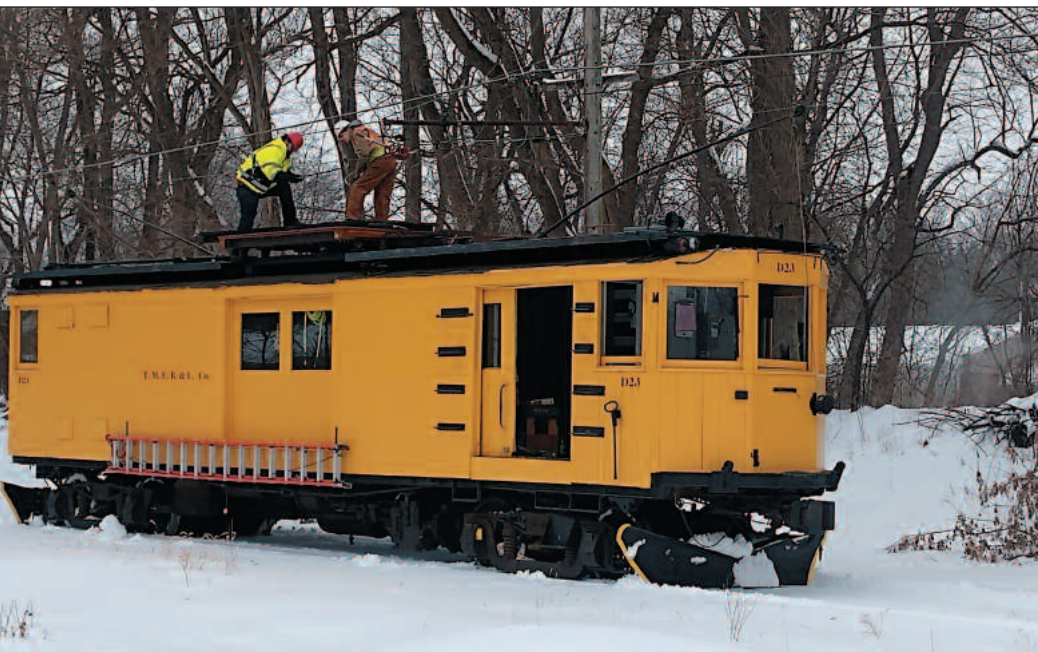
▼ On February 2, 2019, 37 years after Russ Porter took his classic winter repair photo, Chris Schmidt and Zach Frame are on top of D-23 making a similar repair. —Haylee Wilcox photo

The roof of D-23 has three mechanical platforms to allow access to the overhead wire for maintenance and construction. The center platform rises some five feet via a 600-volt motor inside the car, and then has a swing-out extension that enables the

repair crews to reach the line poles. Much like the single-truck line car described earlier, D-23 has roof-mounted controls that allow operation of the car from the platforms above it.

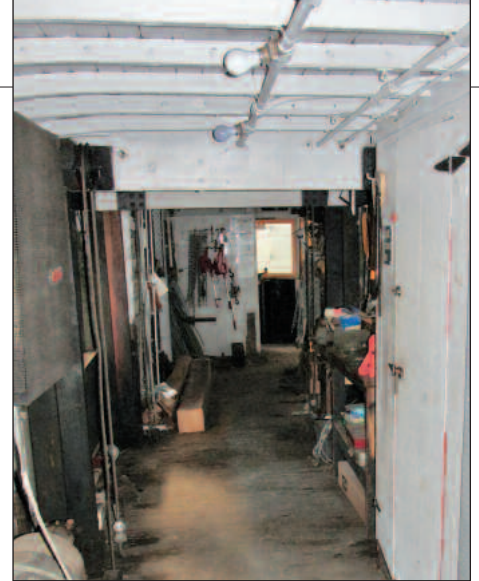
▲ The interior of D-23 today, looking toward the west end of the car. —Author’s photo

The mechanical platforms are insulated from the rest of the car, so the overhead repair crew can work on energized wire without having to worry about being shocked or electrocuted. The interior of D-23 has workbenches, tools, numerous bins filled with repair parts, storage cabinets,

and a trolley-wire dispensing reel.

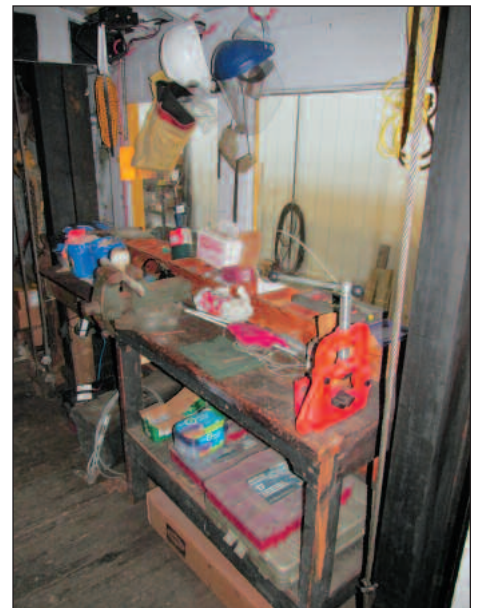
▲ The workbench has bins with smaller parts along the back. How many men have used this bench to make repairs since 1907?

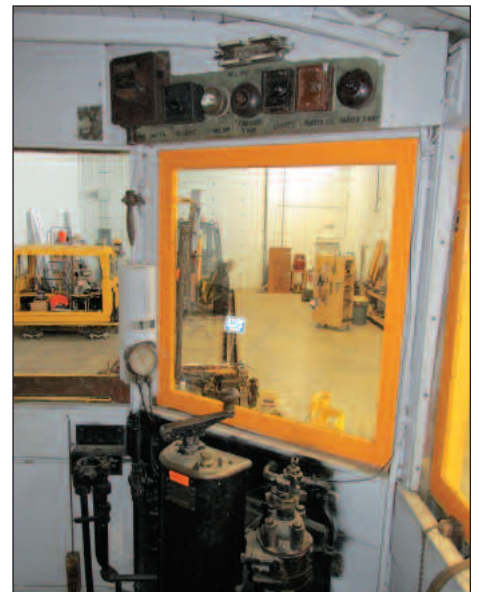
▼ Here is the control stand at the east end of the car. The interior of the East Troy Railroad’s maintenance facility can be seen through the windows. —Two Author’s photos

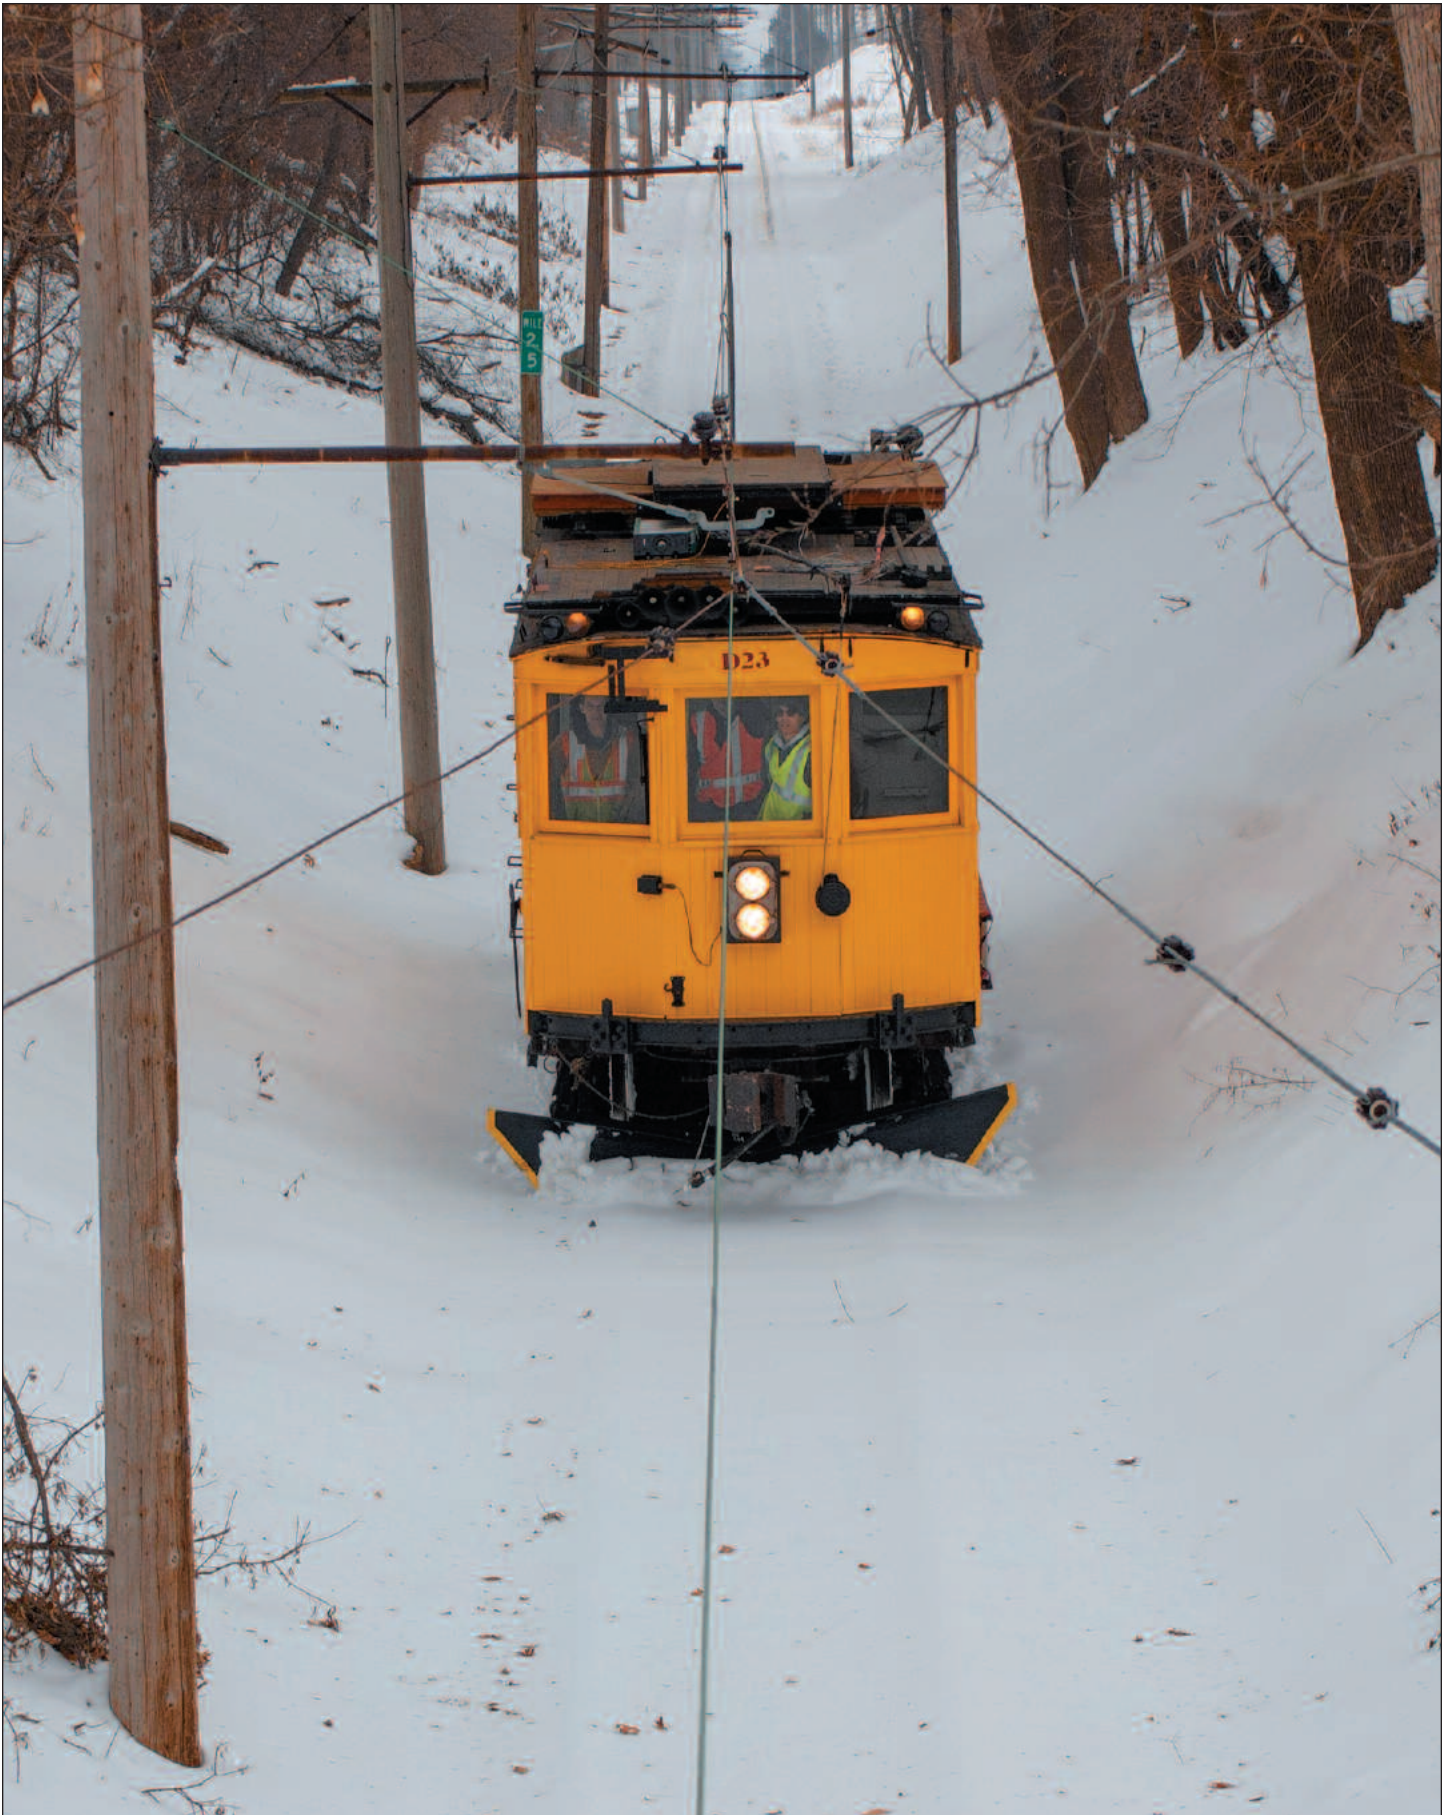
▲ Car D-23 plowing snow on the East Troy Electric Railroad on February 2, 2019. —Tom Fleming photo
